Safety Inspection Report

Annual Inspection

Oxgangs Primary School

09 October 2023

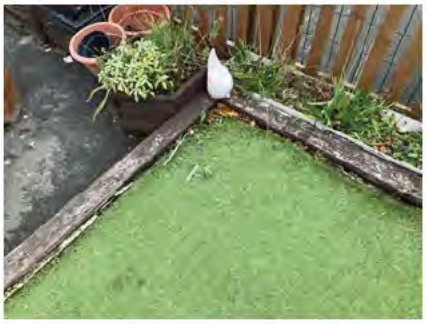
Timber is decayed.

Timber retainer.

Risk level:

Medium

Risk score:

8

Replace affected parts.
