Safety Inspection Report

Annual Inspection

Oxgangs Primary School

09 May 2024

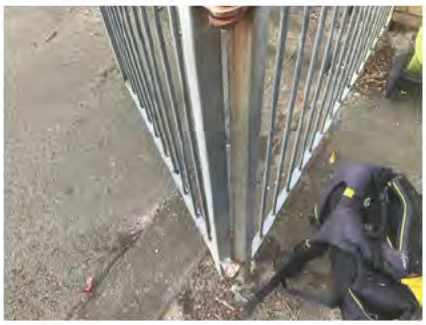
There is a crushing or shearing point on the side of the gate. Where the gaps reduce to less than 12 mm these have been known to cause serious, permanent injury to children, especially on the hinge side where the leverage forces are significant.

9

Adjust gate / posts / fit new rubber buffer to ensure a spacing of at least 12 mm throughout the range of the gate to remove the entrapment. The 12 mm gap also should apply on the hinge side of the gate.

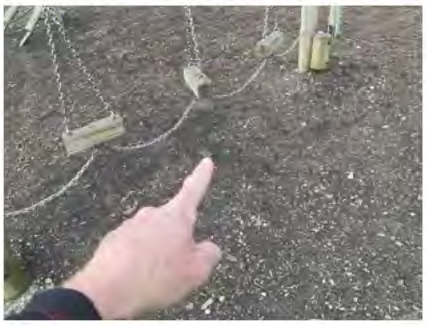
The foundations are exposed.

9

Cover the foundations to an appropriate depth.

Remove surface hazards.

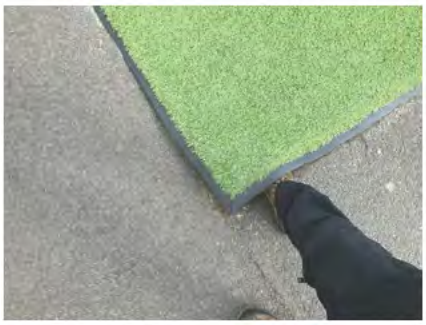
Surface needs repair.

6
