**ROAD LAYOUT  
HOUSING DEVELOPMENT  
FROGSTON ROAD (POD A, SITE 1)  
EDINBURGH**

STAGE 3 ROAD SAFETY AUDIT  
(SPA Ref No: 4282)

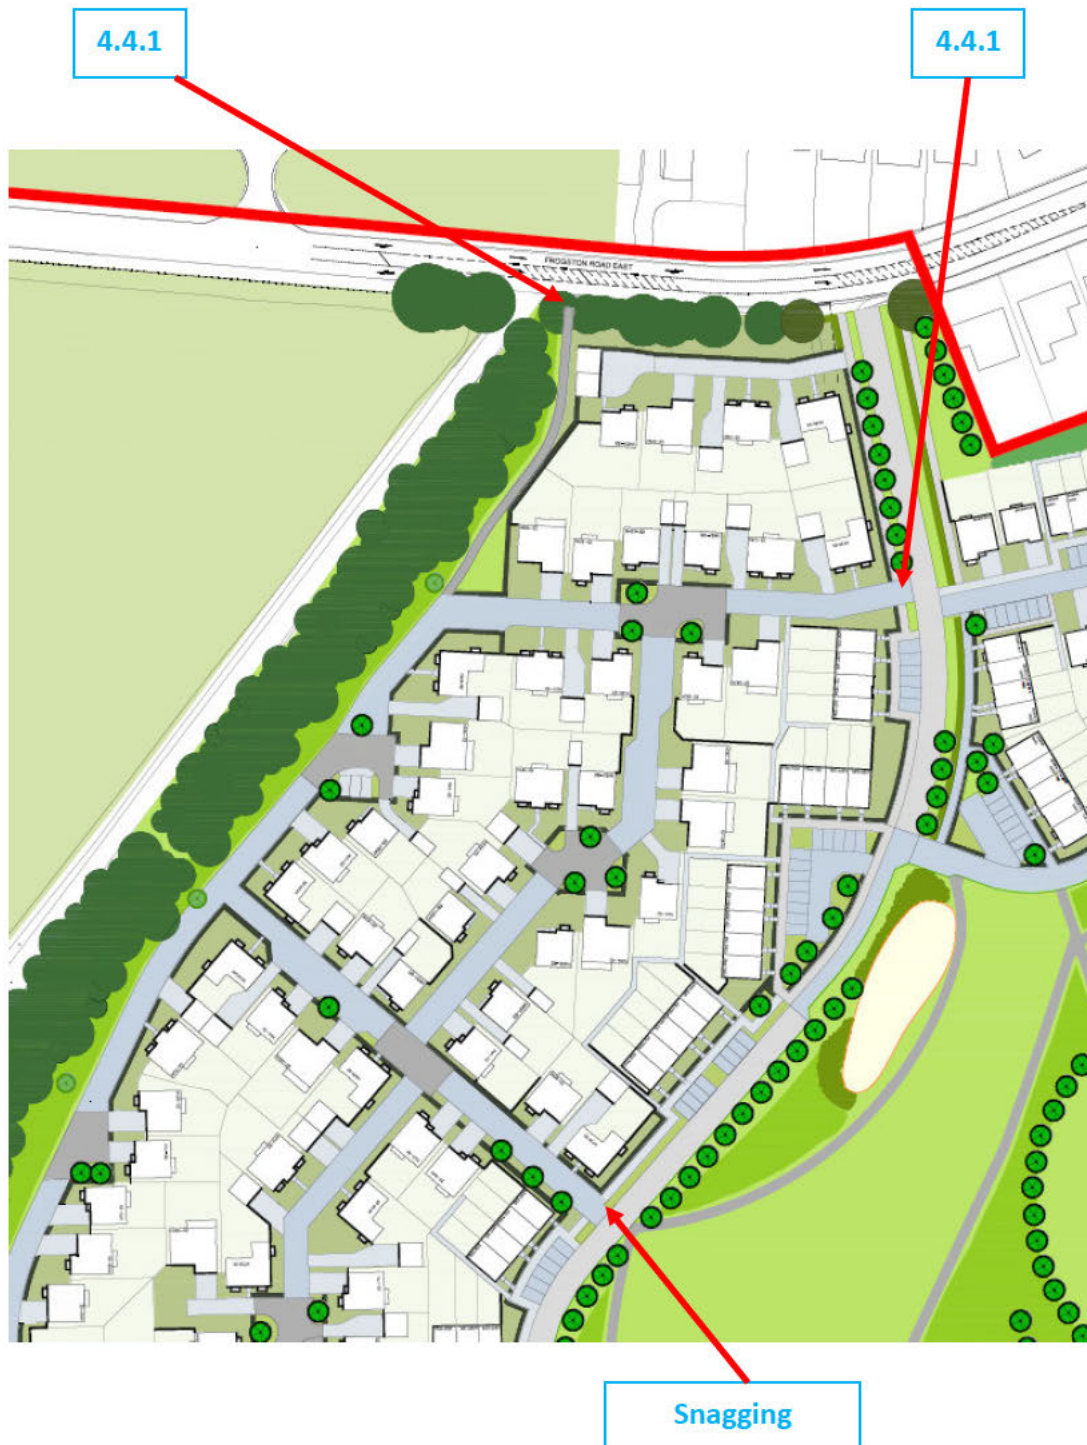
## Annex 2 PROBLEM LOCATION PLAN

- Specific problem areas have been identified and referenced by the comment number in the text
- General issues covering multiple areas have not been highlighted on this plan so as to avoid clutter and potential misinterpretation.
