**ROAD LAYOUT
HOUSING DEVELOPMENT
FROGSTON ROAD (POD G, Ph 1, SITE 4)
EDINBURGH**

STAGE 3 ROAD SAFETY AUDIT
(SPA Ref No: 4282)

Roads Authority: The City of Edinburgh Council

Client: Barratt Homes

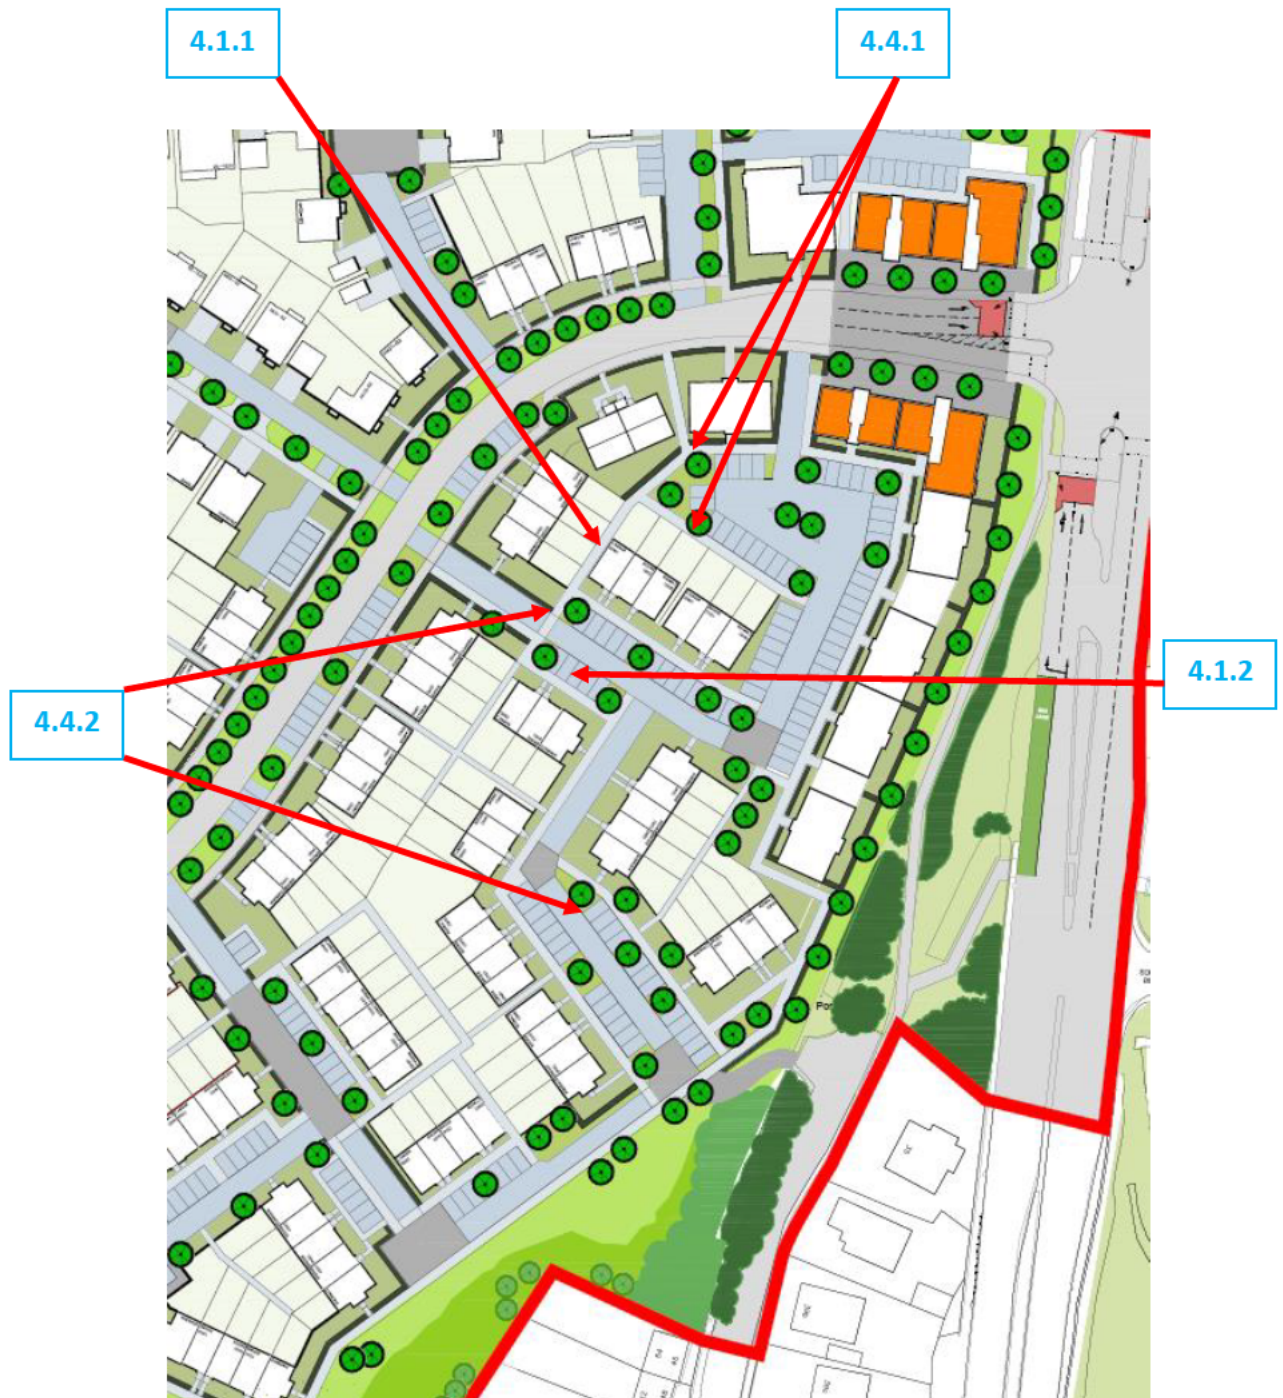
Annex 2 PROBLEM LOCATION PLAN

- Specific problem areas have been identified and referenced by the comment number in the text
- General issues covering multiple areas have not been highlighted on this plan so as to avoid clutter and potential misinterpretation.

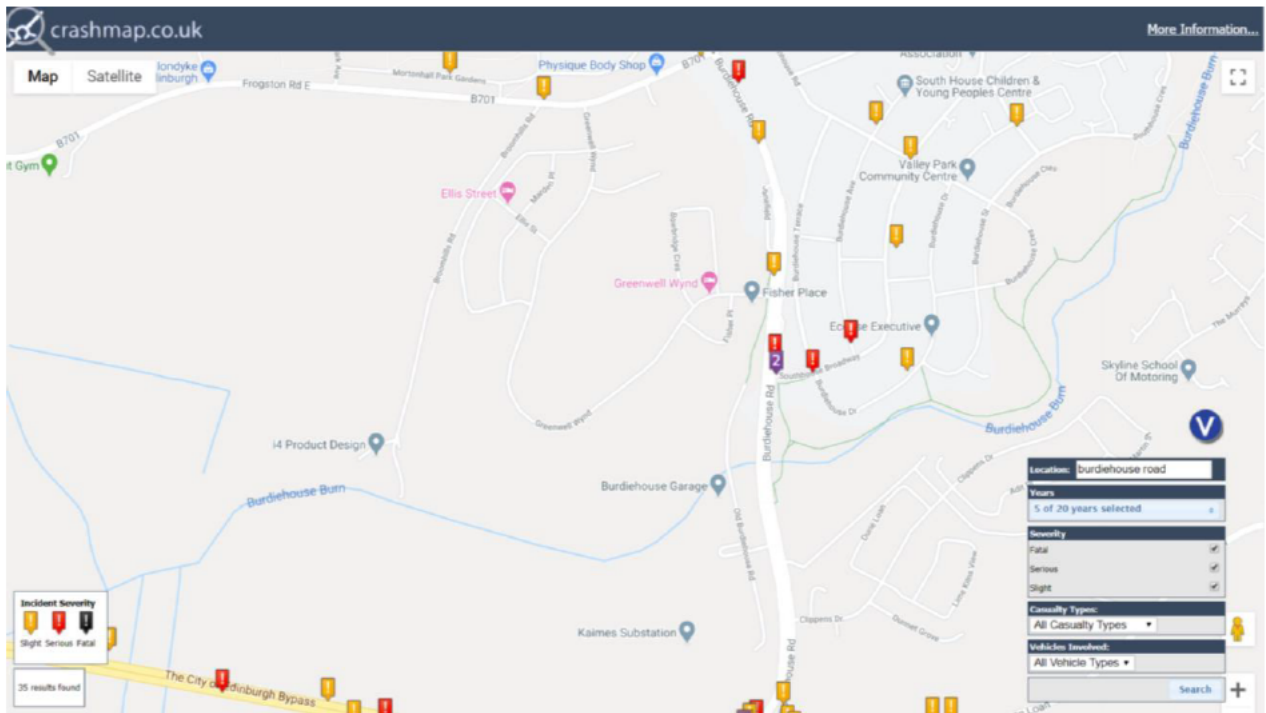
Annex 3 ACCIDENT RECORD

- 2.1 In the absence of any specific accident records being provided the Road Safety Audit Team have examined the website www.crashmap.co.uk for injury accidents recorded at the site.
- 2.2 A map based plan of the accidents have been provided in Annex 3
- 2.3 It is noted that for the five-year period from 2014 -2018 there were no accidents directly related to the area of the new development.
