## Asbestos Refurbishment Survey (with MA + PA)

Client Details	City of Edinburgh Council, Waverley Court, First Floor, Area 1.4, 4 East Market Street, Edinburgh, EH8 8BG
Site Details	Kaimes Special School, 140 Lasswade Road, Edinburgh, , EH16 6RT UPRN:
Date(s) of Surveys	13 Nov 2025
Report Reference Number	J139671
Brief Survey Scope of Works	Refurbishment Survey The scope of the survey was defined by Carin McLachlan of Franks Portlock and as defined in survey request document SR 184-2025-K.

Site address:	Kaimes Special School, 140 Lasswade Road, Edinburgh, , EH16 6RT		
Survey Type:	Refurbishment Survey		
Date of Survey:	13th November 2025		
Lead Surveyor(s):

Report generated date:	5 Dec 2025		
Agreed Scope of Work:	Location (s) within property: Building K1, Circulation 063 Detailed Scope of Works: Removal of rotten plasterboard damaged by continuous roof leaks (job ref MTC50086056). Our records show asbestos residue to metal roof and steel beams from textile firebreak in the Circulation 063. The residue is not visible on the photos (see attached) so it may be present in another area of the circulation space. There are also asbestos cement infill panels behind fibre board panels

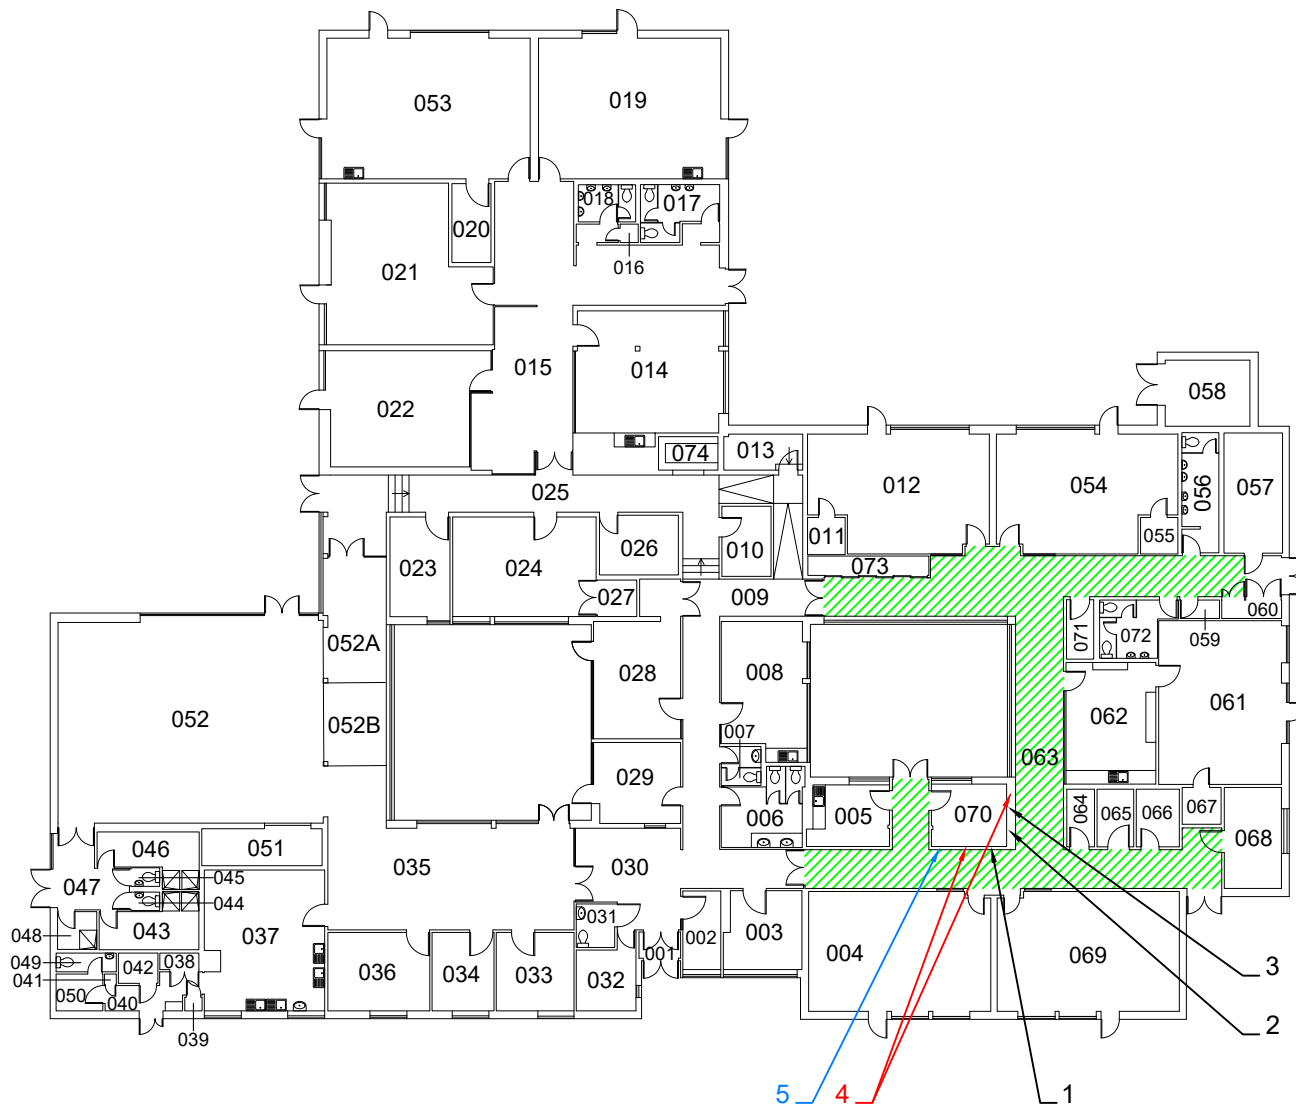
Please Note: Asbestos containing materials item locations are only indicative of the area of location not the exact position of the material; refer to previous sections for details.

- Positive Item
- Negative/non-asbestos item
- Inaccessible item
- Area in scope
