Spaces for People

Scheme Review Form

Location	Original justification
Morningside Town Centre	To provide safe space for pedestrians to walk, exercise and access local shops. To provide safe cycling routes and prioritise public transport as an alternative to driving.

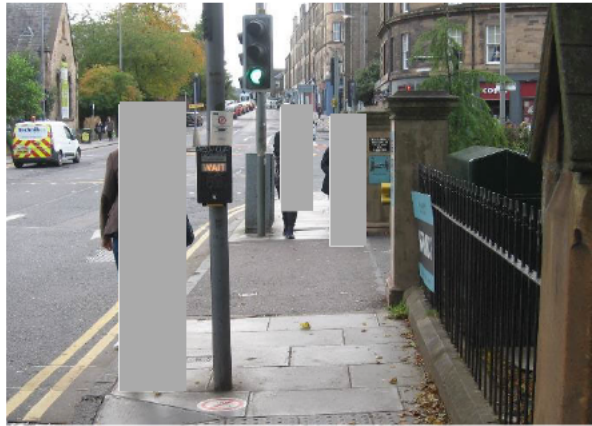
Location 22NW3 (Holy Corner north west):

Despite this being a major pedestrian pinch-point, no SfP measures have been applied to any part of the busy intersection at Holy Corner.

The pavement width here is only 2.2m (ie less than the SDG 'general minimum' of 2.5m) at a busy pedestrian location, and the Clear Walking Zone is just 1.3m (ie less than the SDG 'absolute minimum' of 1.5m). There are long waits for the Green Man phase, during which large numbers of pedestrians can congregate in a way where it is impossible to maintain social distancing.

A further hazard to pedestrians is the vehicular access to McLaren's restaurant, across which lorries and vans regularly reverse.

Recommendation: in the short term, increase the frequency of the Green Man phase.

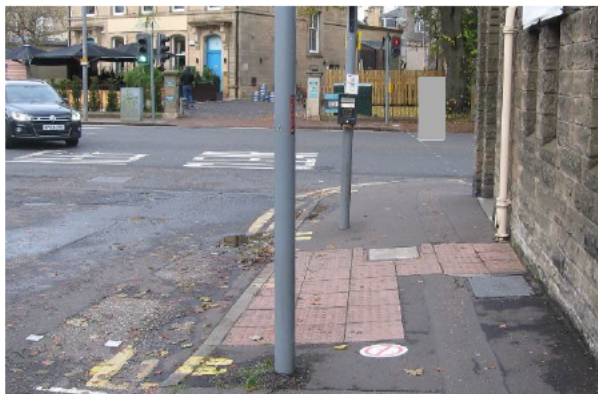
Location 22NE2 (Holy Corner north east):

The pavement here is only 2.4m wide, and the Clear Walking Zone is just 1.6m. There are long waits for the Green Man phase, during which large numbers of pedestrians can congregate in a way where it is impossible to maintain social distancing.

Recommendation: as per Location 22NE1 above.

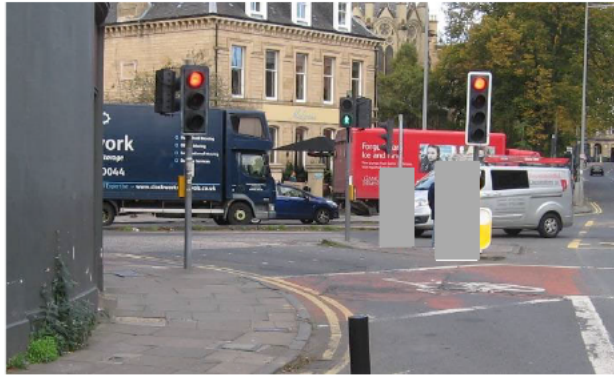
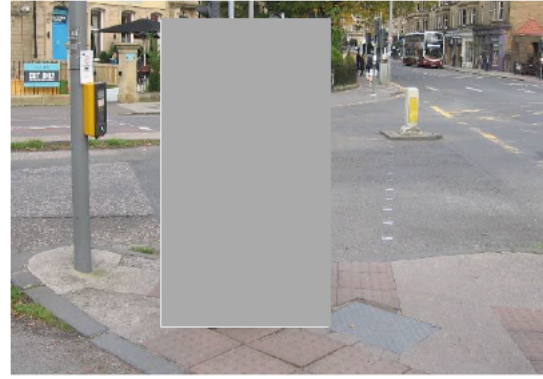
Location 22SW1/2 (Holy Corner south west):

The pavement width beside Costa (left photo) at the waiting area for the crossing is only 2.2m, and the Clear Walking Zone is just 1.5m. The width of the pedestrian island part-way across Colinton Road (right photo) ranges from 1.7m to 3.2m.

There are long waits for the Green Man phase, during which large numbers of pedestrians can congregate in a way where it is impossible to maintain social distancing.

Recommendation: in the short term, increase the frequency of the Green Man phase.

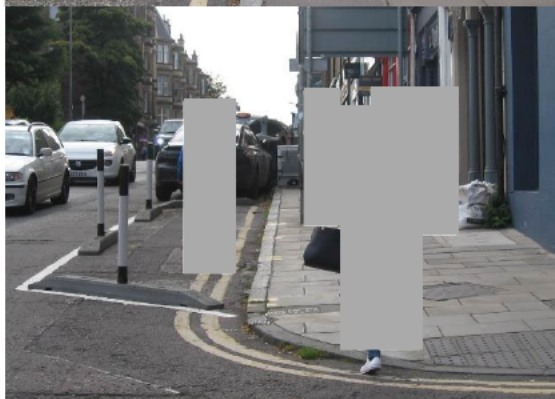
Location 24W (Morningside Road west):

The pavement here is only 2.1m wide (ie less than the SDG 'general minimum' of 2.5m). This is often a busy section of pavement and queuing outside the Post Office is common, therefore the additional SfP space is welcome as a 'social' space and also a 'movement' space.

Recommendation: retain the SfP spaces, and in the longer term permanently widen the pavement proper to create continuous one-level spaces.

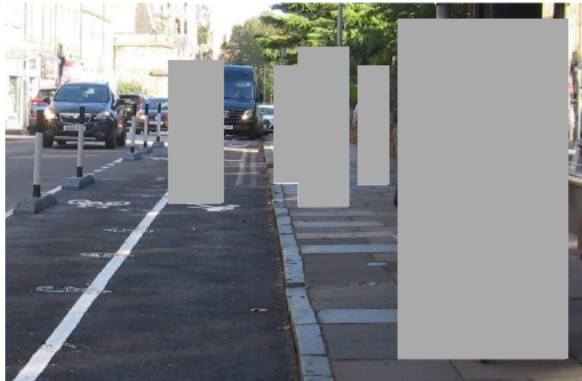
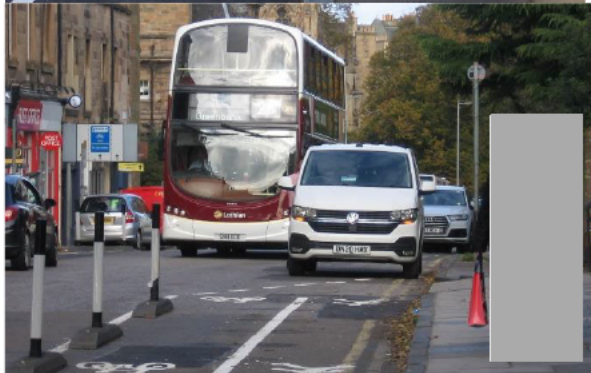
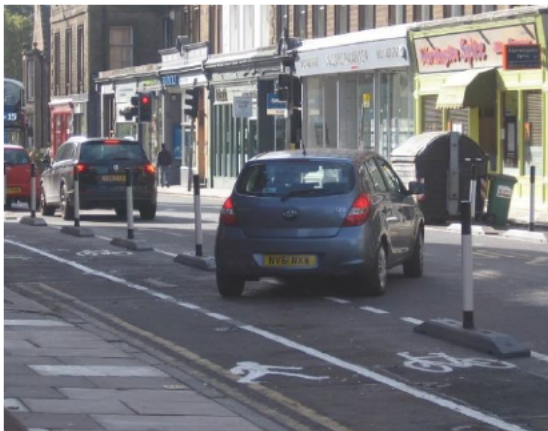
Location 28E (Morningside Road east):

The pavement here is only 2.2m wide (ie significantly less than the SDG 'absolute minimum' of 2.5m), with a Clear Walking Zone of just 1.7m in places, and therefore the additional SfP walking lane (1.35m) is welcome.

However, in the first (temporary) phase of the SfP space there was a physical separation between the walking and cycling lanes, but this has now been removed, leaving only a white line, which does not give sufficient protection for pedestrians.

There is no permanent physical deterrent to vehicles entering the two lanes from the north (top right photo) and on a number of occasions vehicles have been observed using the 'Active Travel' lanes (bottom left photo).

Recommendation: provide a permanent physical deterrent to vehicles entering the 'Active Travel' lanes (plastic cones are currently in place).

In the longer term permanently widen the pavement proper to create a continuous one-level space.

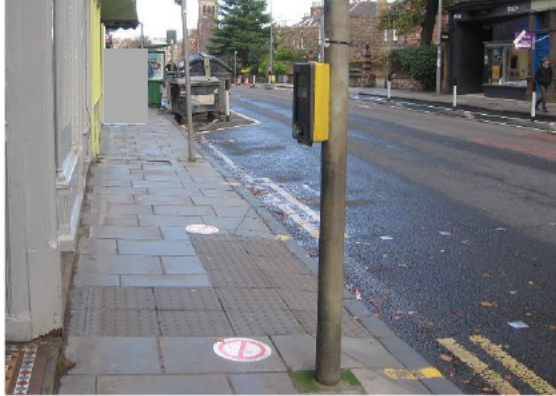
Location 29W (Morningside Road west):

The pavement at the traffic light crossing of Morningside Road on the north side of the junction at Church Hill is only 1.9m wide, with a Clear Walking Zone of just 1.2m at the pole (right photo) – ie both substantially less than the SDG ‘absolute minimum’. Being at a crossing with a long interval between the Green Man phases, this is a location where people unavoidably congregate, in addition to those passing along Morningside Road.

Recommendation: in the short term, increase the frequency of the Green Man phase.

Incorporate new formal cycle parking in the SfP space extension, thereby reducing the problem of informal cycle parking (Location 30W and 31W photos) obstructing pedestrian passage on a very narrow pavement.

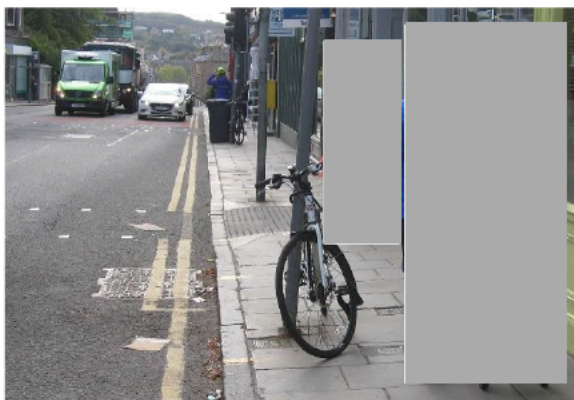
Location 30W (Morningside Road west):

The pavement here is only 1.85m wide (ie substantially less than the SDG 'absolute minimum' of 2.5m), with a Clear Walking Zone of just 1.5m. There are long waits for the Green Man phase, during which large numbers of pedestrians can congregate in a way where it is impossible to maintain social distancing.

Recommendation: as per Location 29W.

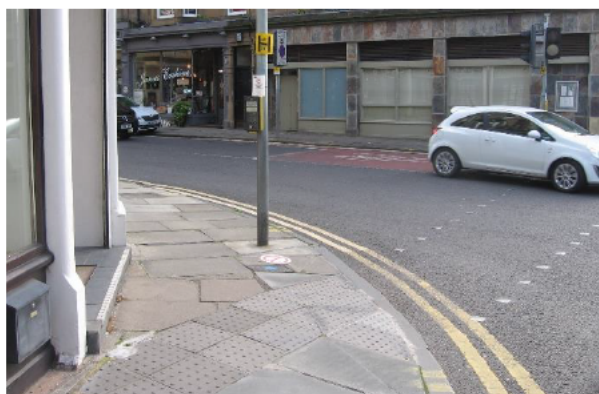
Location 33NE (Morningside Road east):

The pavement here is only 2.4m wide. There are long waits for the Green Man phase, during which large numbers of pedestrians can congregate in a way where it is impossible to maintain social distancing.

Recommendation: in the short term, increase the frequency of the Green Man phase.

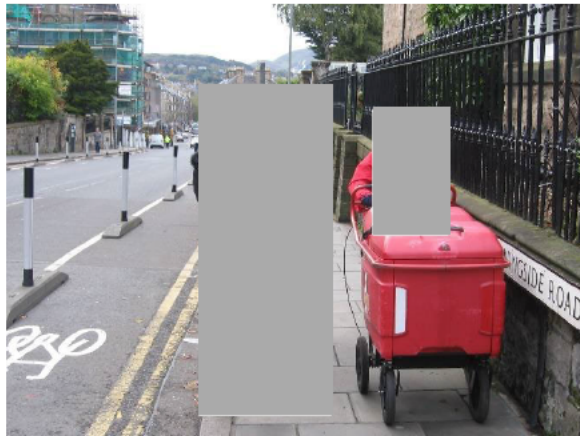
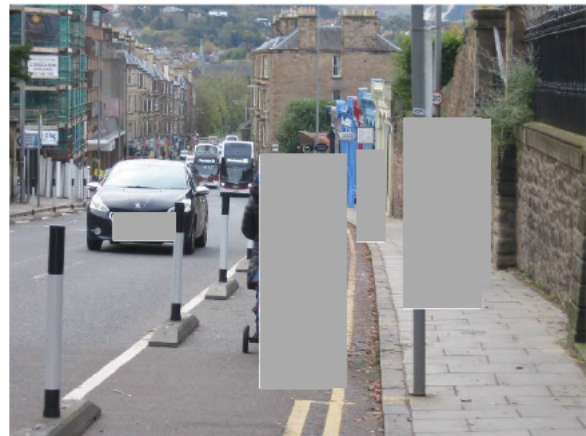
Location 35W (Morningside Road west):

The pavement here is only 1.65m wide (ie substantially less than the SDG 'absolute minimum' of 2.5m) and the Clear Walking Zone is just 1.15m in places. (ie substantially less than the SDG 'absolute minimum' of 1.5m)

During the earlier 'temporary' phase of the SfP project, vertical 'wands' were installed to create a narrow additional width for pedestrians, acting as a buffer zone to clearly distance vehicles from the pavement.

Recommendation: review the relative benefits to cyclists and pedestrians of this design – taking into account the relative number of cyclists and pedestrians on this section) and seek to identify ways of enhancing a severely sub-standard width of pavement.

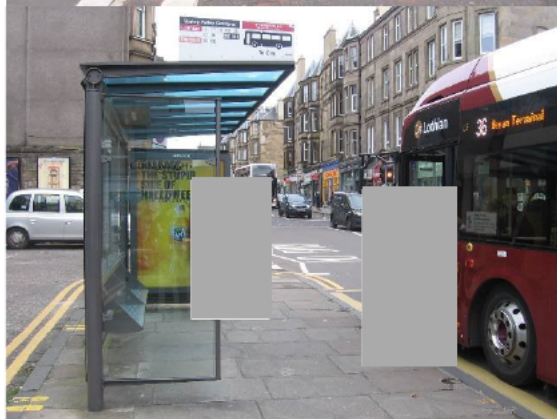
Location 49W (Morningside Road west):

This location is poorly designed for pedestrians, both those walking up or down Morningside Road and those boarding or alighting from buses (this is normally a busy bus

stop). The advertising screen at the north end of the JC Decaux shelter reduces the Clear Walking Zone to just 1.7m at this pinchpoint.

Recommendation: in the short-term replace the advertising screen with a narrower glass panel (like that in the right photo).

In the longer-term explore the scope for a bus build-out and/or a complete redesign of the public realm here (including the carriageway behind the bus stop) in order to prioritise pedestrians and bus users.

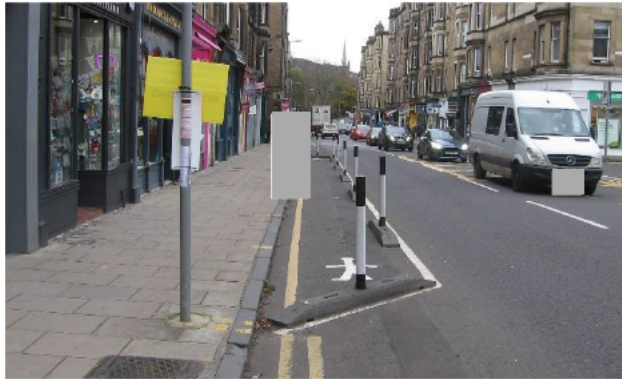
Location 49E (Morningside Road east):

The pavement here is only 2.7m wide, and the signage pole (and SfP sign), and therefore the additional 1.4m SfP space is welcome.

Recommendation: retain the SfP space, and in the longer term permanently widen the pavement proper to create a continuous one-level space.

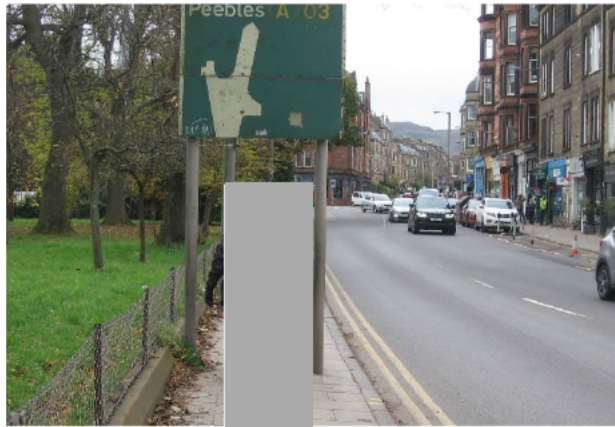
Location 56E (Morningside Road east):

The pavement here is only 1.8m wide (ie substantially less than the SDG 'absolute minimum' of 2.5m) and the Clear Walking Zone at the poles is just 1.05m (ie substantially less than the SDG 'absolute minimum' of 1.5m).

Recommendation: in the short-term erect a new sign on a single pole. In the longer-term review the whole street design to create a much more pedestrian-friendly environment.

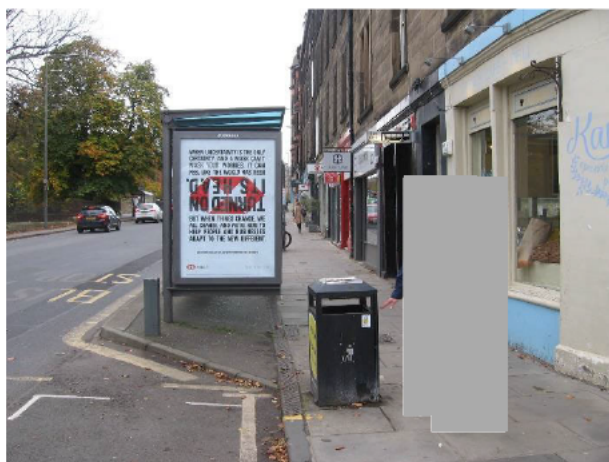
Location 57W1 (Morningside Road west):

The bus build-out helps to relieve a pavement which is otherwise only 2.7m wide, but the inappropriately located litter bin reduces the Clear Walking Zone to just 1.8m

Recommendation: relocate the litter bin to the bus build-out.

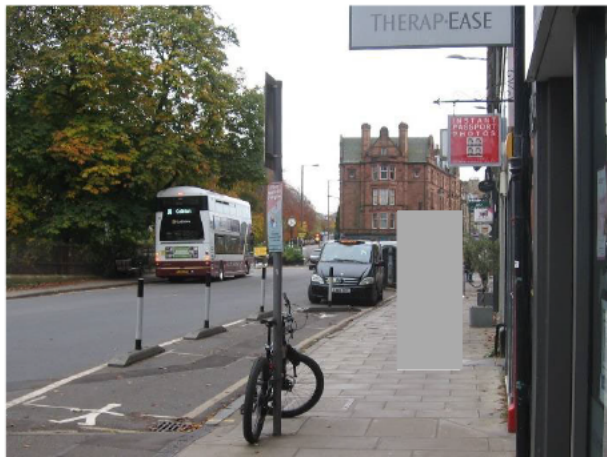
Location 57W2 (Morningside Road west):

The pavement here is only 2.9m wide and the Clear Walking Zone is reduced by the informal bike parking and pole – and therefore the additional 2m SfP space is welcome.

Recommendation: retain the SfP space, create formal cycle parking facilities within the SfP space, and explore the scope for the sign on the pole to be relocated on the building wall.

In the longer term permanently widen the pavement proper to create a continuous one-level space.

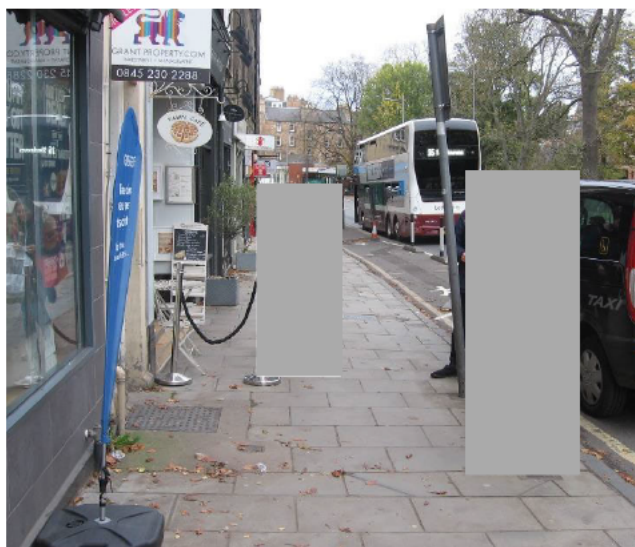
Location 58W (Morningside Road west):

The pavement here is 3.15m wide, but the Clear Walking Zone at the signage pole is just 1.4m wide (ie less than the SDG 'absolute minimum' of 1.5m).

Recommendation: review the tables & chairs licence for the café, and explore the scope for the sign on the pole to be relocated on the building wall. Remind the owner of the blue 'feather' advert about the city-wide ban on advertising boards.

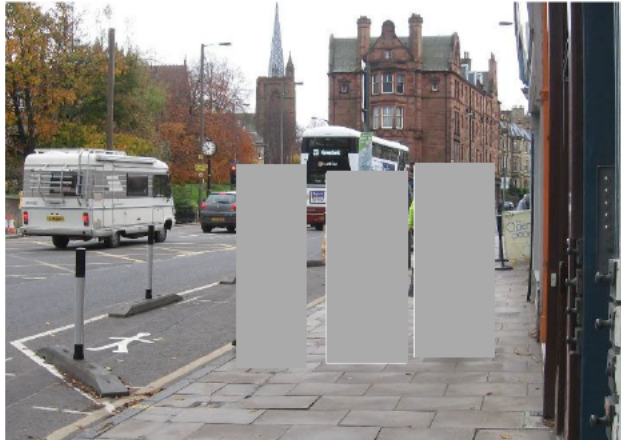
Location 59W (Morningside Road west):

The pavement here is only 2.95m wide (ie less than the SDG 'general minimum' of 3m) and therefore the additional SfP space is welcome.

Recommendation: retain the SfP space, and in the longer term permanently widen the pavement proper to create a continuous one-level space.

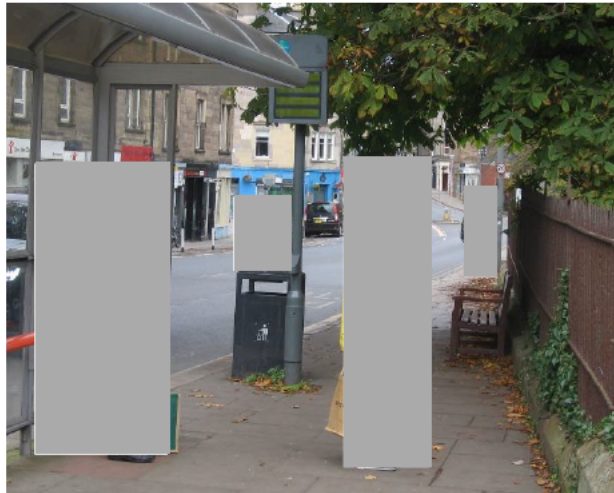
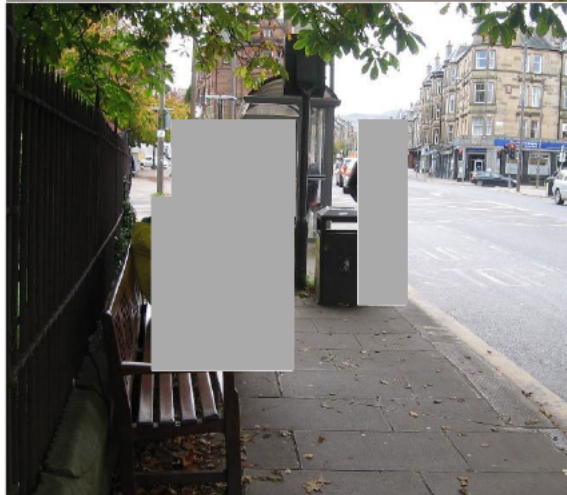
Location 59E (Morningside Road east):

The pavement at the bus stop is only 2.9m wide, with a Clear Walking Zone of just 1.7m. At the bench the pavement is only 2.4m wide, with a Clear Walking Zone of just 2m.

Recommendation: review the design, potentially relocating the litter bin and the bus tracker pole, and moving the bench slightly closer to the bus stop.

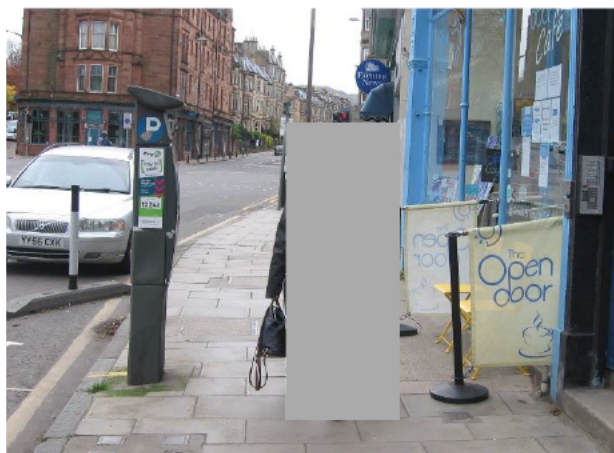
Location 60W (Morningside Road west):

The pavement here is only 2.85m wide, and the tables & chairs and parking ticket machine reduce the Clear Walking Zone to just 1.6m.

Recommendation: review the tables & chairs licence for the café, and explore the scope for the parking ticket machine to be relocated into the SfP space.
