## STAGE 3 ROAD SAFETY AUDIT REPORT FOR EDINBURGH TRAM NETWORK

Report Reference:-  
Airport – York Place Final Stage3.

Date 06.04.2014

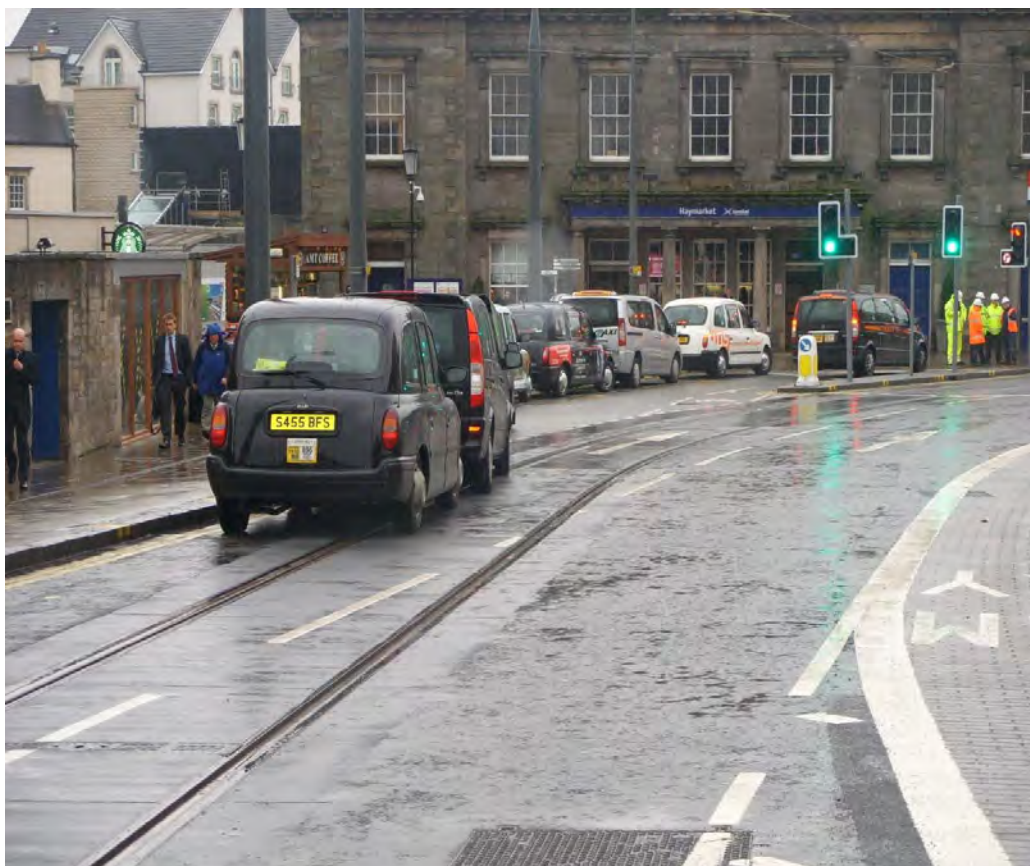
Where cyclists are required to cross the tram tracks it is recommended they do so at angles close to 90 degrees.

Whilst cars and buses can deviate around the extended taxi queue, trams will not be able to do so. Their progress will be halted by taxis' queuing in their lane. It is less likely the queue will extend into the tram tracks after the trams start to use this section of track.

## Recommendations.

1. Continue to enforce the breach of the existing waiting restrictions by the taxi drivers.
2. Temporarily plug the tram tracks at this location until the trams start operating here.
3. Provide an alternative nearby feeder rank that taxis can use when this existing rank is full. This feeder rank should be equipped with a monitor to show taxi drivers when there is space available at the Haymarket Station taxi rank.
4. Monitor taxi driver and cyclist behaviour by CCTV and take appropriate enforcement action if required.
