**From:** [REDACTED]  
**To:** [REDACTED] [Michael Miller](#); [Sandy Rintoul](#)  
**Cc:**  
**Subject:** RE: E20955.00 - St Cuthbert's RC Primary School  
**Date:** 27 August 2026 09:48:59  
**Attachments:** [image001.png](#)  
[image002.png](#)  
[image003.png](#)  
[image004.png](#)  
[image005.png](#)  
[image006.png](#)  
[image007.png](#)  
[image008.png](#)  
[faac604c-db2d-4730-9a3c-97d7c6212cc3.png](#)  
[St Cuthbert's RC Primary School - Skanska - CPP review.pdf](#)  
[26279 - St Cuthbert's RC Primary School PCIP 2026.pdf](#)

## St Cuthbert's RC Primary School - Construction Phase H&S Plan Review Checklist

## **Structural Strengthening Works**

**ASBESTOS MANAGEMENT SURVEY  
OF  
ST CUTHBERTS PRIMARY SCHOOL, 9 HUTCHISON CROSSWAY, EDINBURGH, EH14 1RP**

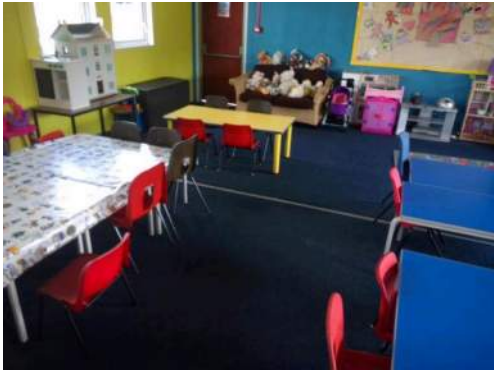
| <b>FLOOR/LOCATION:</b> | Z-Sub Level 1 Floor Void | |

| <b>DESCRIPTION:</b> | Inaccessible | |
| <b>RESULT:</b> | Presumed | |

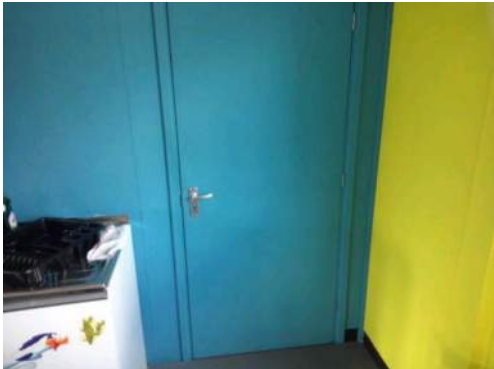
| <b>FLOOR/LOCATION:</b> | Ground Floor 0/005 - Store | |

| <b>DESCRIPTION:</b> | Inaccessible | |
| <b>RESULT:</b> | Presumed | |

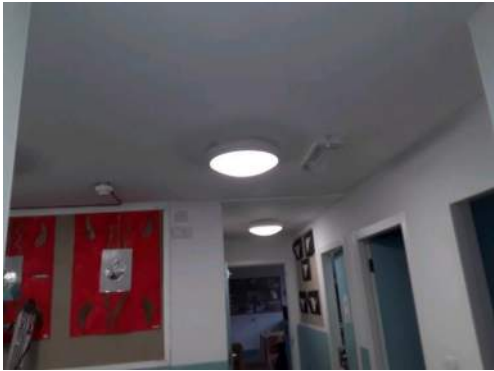
| <b>FLOOR/LOCATION:</b> | Roof Void RV/001 - Roof Void | |

| <b>DESCRIPTION:</b> | Inaccessible | |
| <b>RESULT:</b> | Presumed | |

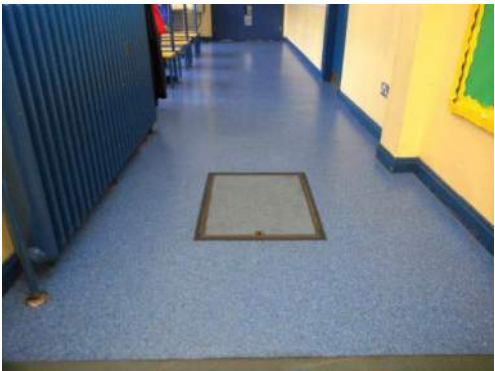
| <b>FLOOR/LOCATION:</b> | Z-Sub Level 1 Z1/002 - Ducts | |

| <b>DESCRIPTION:</b> | Inaccessible | |

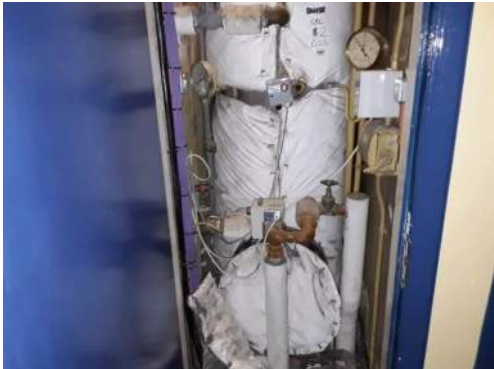
| <b>FLOOR/LOCATION:</b> | Ground Floor 0/031 - Calorifier Room | |

| <b>DESCRIPTION:</b> | Presumed asbestos containing materials within calorifier and pipework beneath modern insulating blankets and MMMF lagging - Unable to sample due to sampling exposed surface areas | |

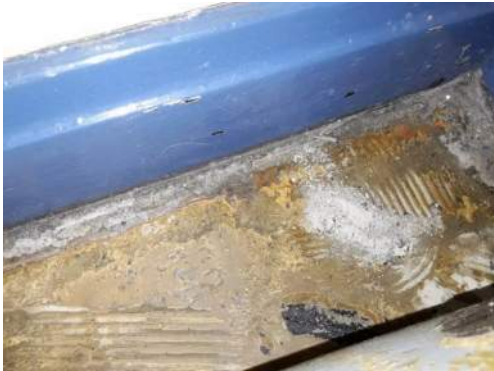
| <b>FLOOR/LOCATION:</b> | Ground Floor 0/042 - Circulation | |

| <b>DESCRIPTION:</b> | Bitumen adhesive beneath carpet and modern floor covering | |
| <b>RESULT:</b> | Chrysotile | |

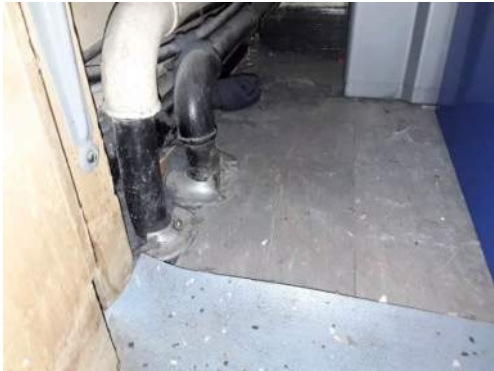
| <b>FLOOR/LOCATION:</b> | Ground Floor 0/043 - Store | |

| <b>DESCRIPTION:</b> | Grey floor tiles | |
| <b>RESULT:</b> | Chrysotile | |

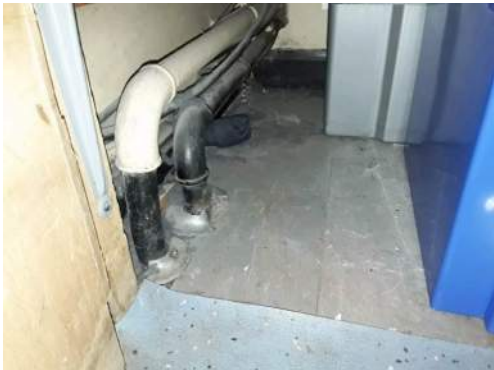
| <b>FLOOR/LOCATION:</b> | Ground Floor 0/043 - Store | |

| <b>DESCRIPTION:</b> | Bitumen adhesive beneath floor tiles | |
| <b>RESULT:</b> | Chrysotile | |

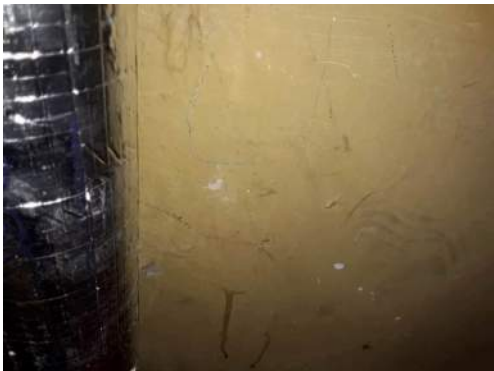
| <b>FLOOR/LOCATION:</b> | Ground Floor 0/044 - Calorifier Room | |

| <b>DESCRIPTION:</b> | Insulation residue to wall 2 | |
| <b>RESULT:</b> | Amosite | |

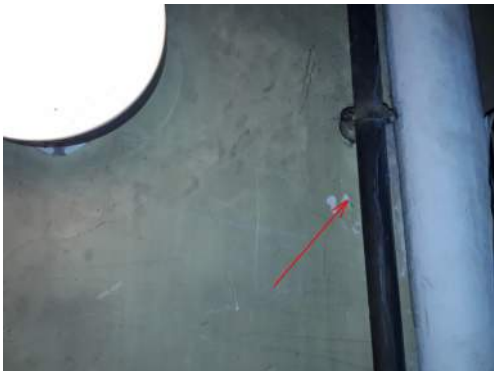
| <b>FLOOR/LOCATION:</b> | Ground Floor 0/044 - Calorifier Room | |

| <b>DESCRIPTION:</b> | Insulation residue to wall 4 | |
| <b>RESULT:</b> | Amosite | |

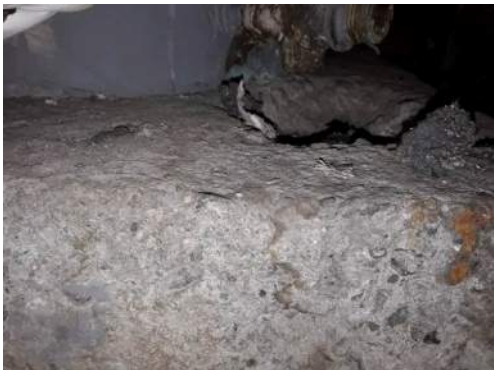
| <b>FLOOR/LOCATION:</b> | Ground Floor 0/044 - Calorifier Room | |

| <b>DESCRIPTION:</b> | Insulation debris to floor and plinth | |
| <b>RESULT:</b> | Amosite | |

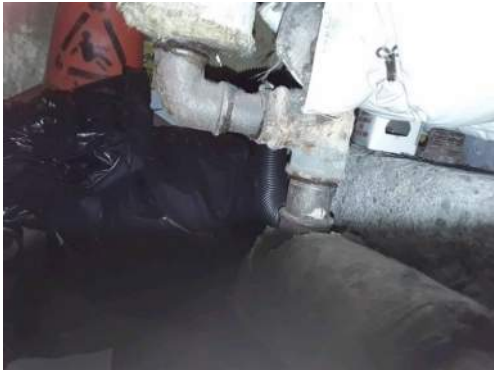
| <b>FLOOR/LOCATION:</b> | Ground Floor 0/044 - Calorifier Room | |

| <b>DESCRIPTION:</b> | Insulation residue to pipework/calorifier knuckles, fixings and joints throughout entire area. | |
| <b>RESULT:</b> | Amosite | |

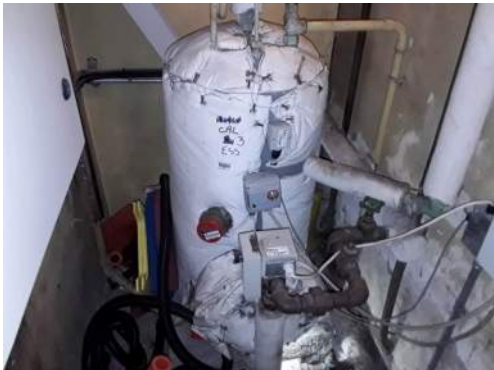
| <b>FLOOR/LOCATION:</b> | Ground Floor 0/044 - Calorifier Room | |

| <b>DESCRIPTION:</b> | Presumed asbestos containing materials within calorifier and pipework beneath modern insulating blankets and MMMF lagging - Unable to sample due to sampling exposed surface areas | |
| <b>RESULT:</b> | Presumed Crocidolite (or unknown) | |

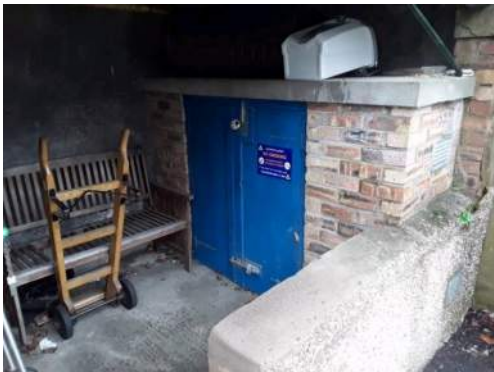
| <b>FLOOR/LOCATION:</b> | Ground Floor 0/049B - Gas Mains | |

| <b>DESCRIPTION:</b> | Inaccessible | |
| <b>RESULT:</b> | Presumed | |

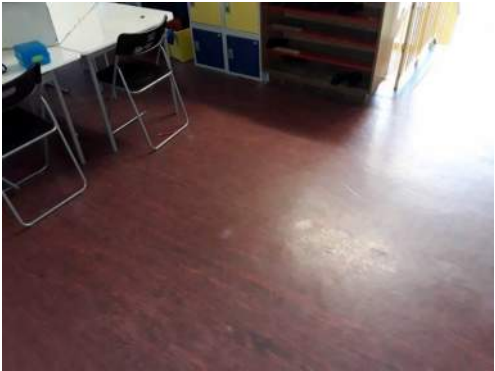
| <b>FLOOR/LOCATION:</b> | 1st Floor 1/056 - Circulation | |

| <b>DESCRIPTION:</b> | Bitumen adhesive beneath red modern floor covering | |
