**ASBESTOS MANAGEMENT SURVEY  
OF  
ST CUTHBERTS PRIMARY SCHOOL, 9 HUTCHISON CROSSWAY, EDINBURGH, EH14 1RP**

**CLIENT: THE CITY OF EDINBURGH COUNCIL  
WAVERLEY COURT, 4 EAST MARKET STREET, EDINBURGH, EH8 8BG**

**UPRN NO: N/A  
PROJECT NO: J511797  
DATE: APRIL 2019**

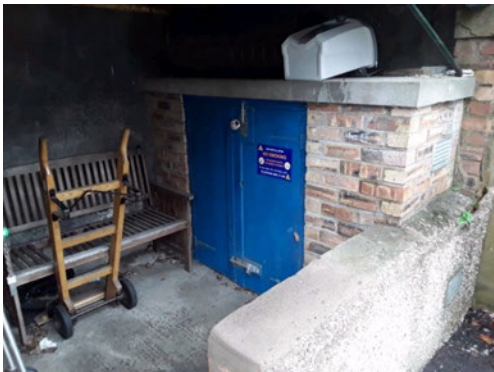
| <b>FLOOR/LOCATION:</b> | Ground Floor 0/049B - Gas Mains | |
| <b>DESCRIPTION:</b> | Inaccessible | |
| <b>RESULT:</b> | Presumed | |

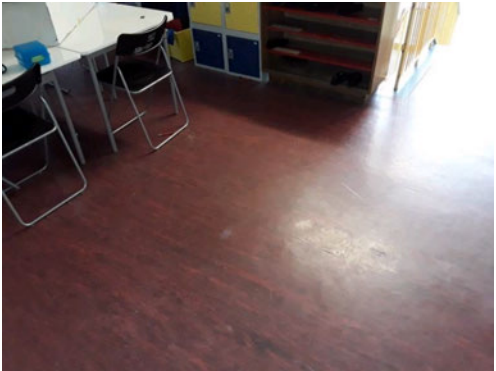
| <b>FLOOR/LOCATION:</b> | 1st Floor 1/056 - Circulation | |
| <b>DESCRIPTION:</b> | Bitumen adhesive beneath red modern floor covering | |
