SF/KL/E14804

## 29 - 35 Baberton Mains Avenue, Edinburgh Fire Damage

PROJECT TITLE:  
**BABERTON MAINS AVENUE.  
EXPLOSION INCIDENT  
STRUCTURAL RESPONSE**

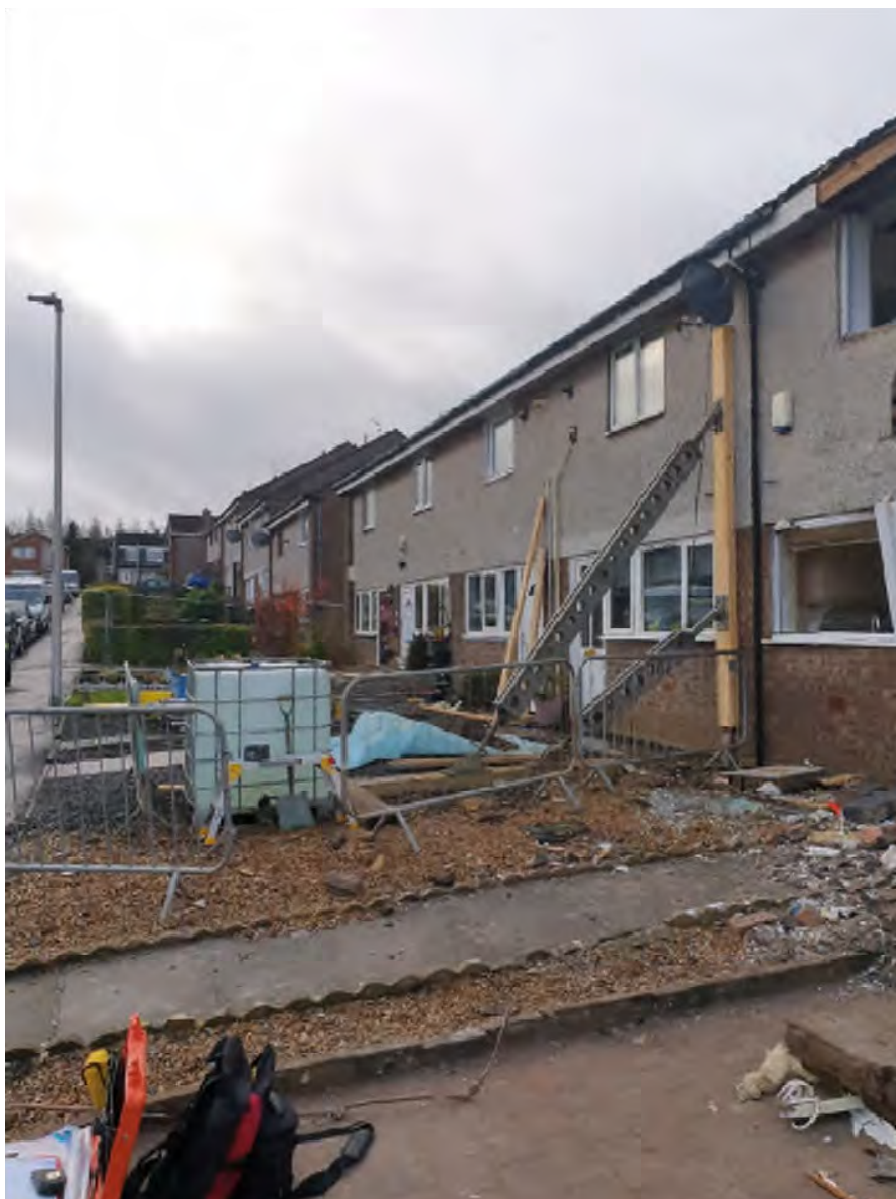
23 - 29 Baberton Mains Avenue

This property is located 2 properties away from the explosion location. It has suffered what appears to minor damage with slight cracking at the party wall with No. 31. However, the degree of damage should be fully assessed in the fullness of time by a suitably qualified structural engineer.

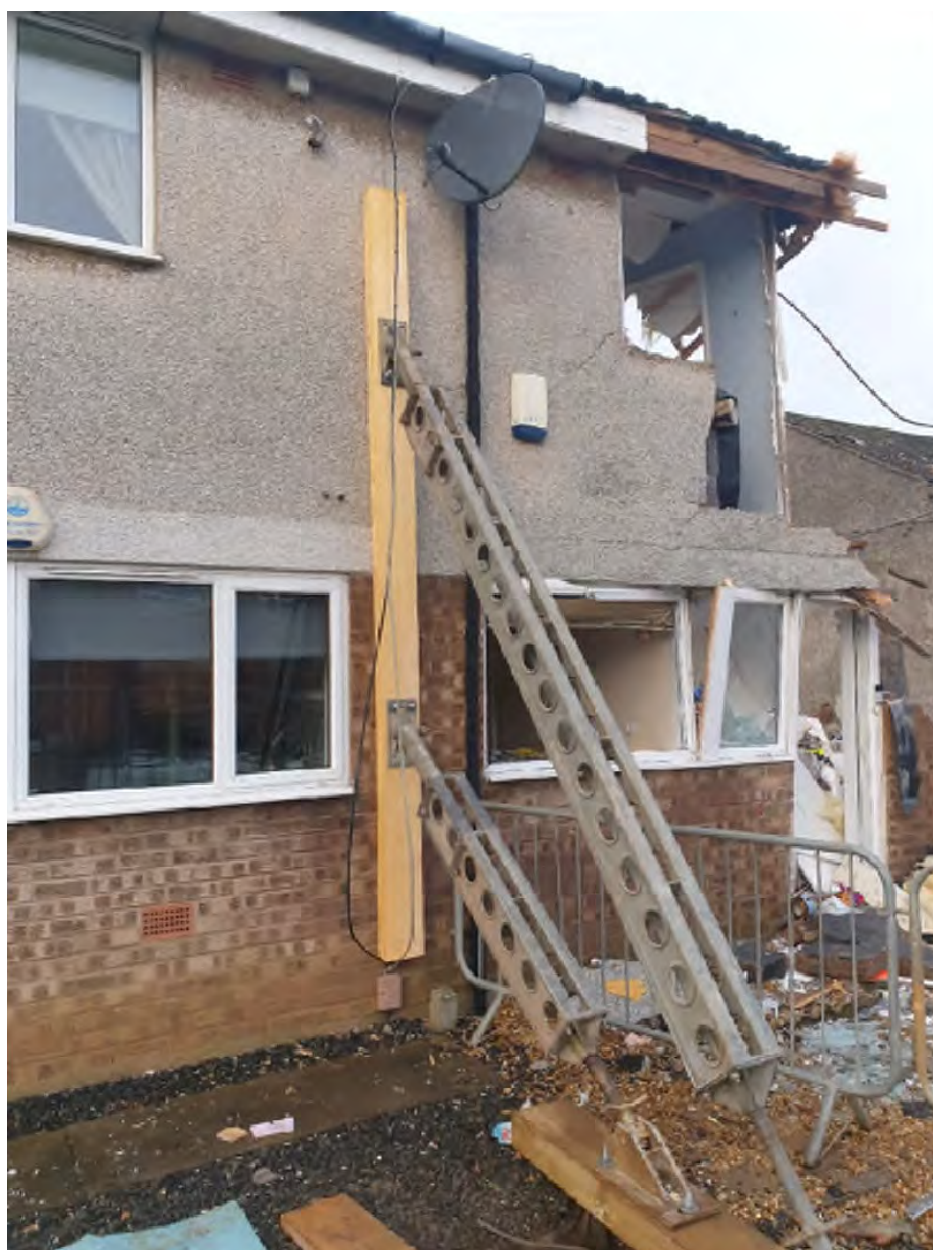
The front elevation remains, which is continuous with the elevation to No. 29, but has substantial cracking and is leaning out, at risk of uncontrolled collapse at first floor level. The Contractor has removed as much loose material as possible, to mitigate this.

As a further precaution a raking shore has been installed at the front to mitigate against the external leaf suffering further damage beyond the extent of no. 31, should any further instability occur to the front elevation to no 31. Eg. in the event of high wind.

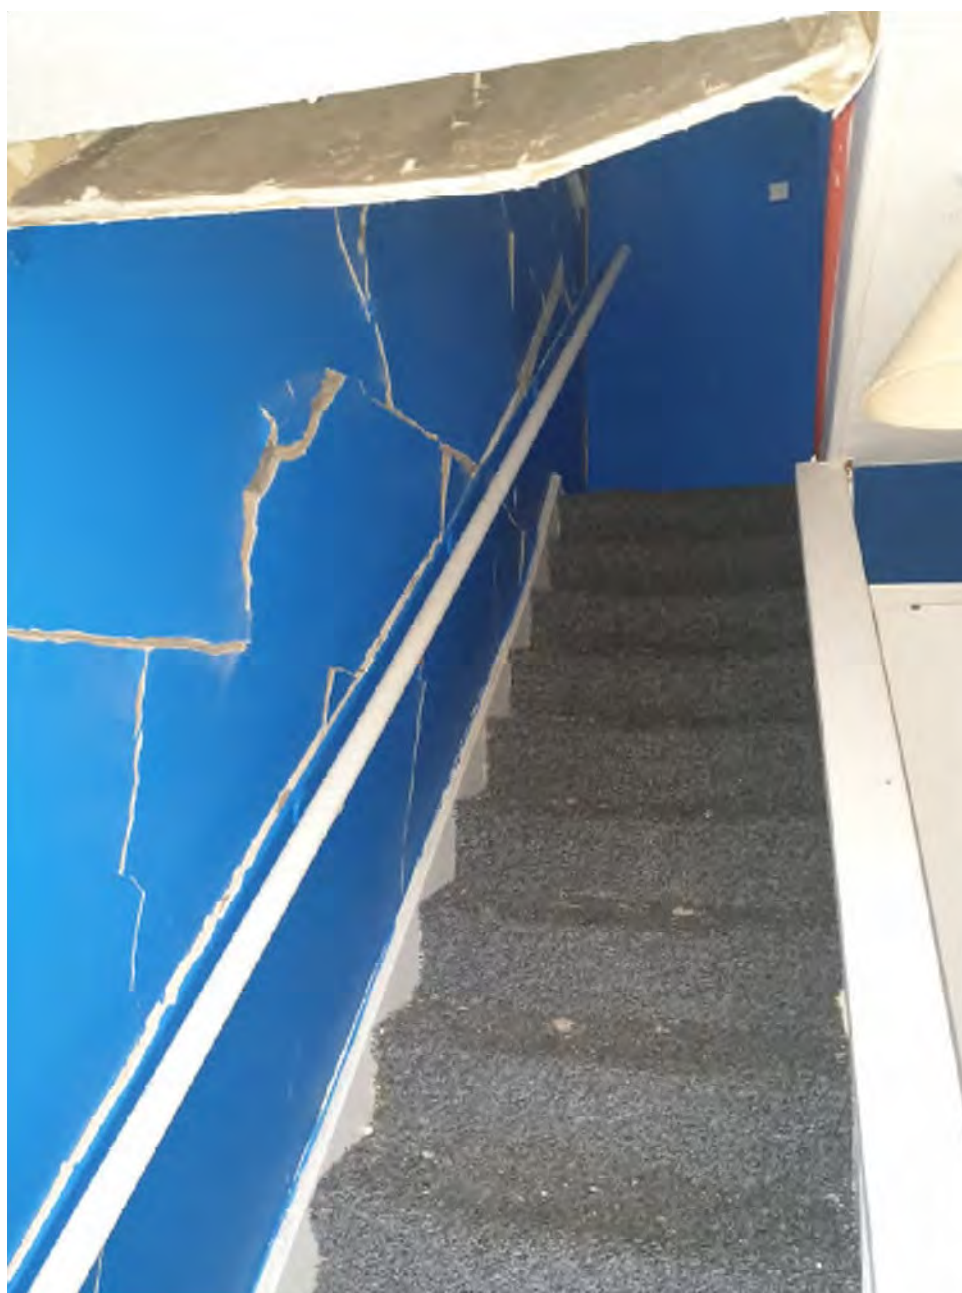
The cavity gable wall to the south of No. 35 appears to have absorbed significant energy from the blast and is now deemed unstable. There is major inward bulging to the gable wall by an estimated 100mm and major cracking, which is particularly evident on the inner face of the wall which has become crazed with random panels of size of some 1m<sup>2</sup> being created. This is visible internally within the stairwell, which is adjacent to the gable. We would deem this wall at significant risk of collapse, which causes a risk to anyone in the immediate fall zone facility adjacent to the gable.

The gable should be carefully taken down and other parts of the structure until a time as only sound parts of the structure remain before building back the missing parts of the structure so as to preserve the structural integrity of the remainder of the property and that of the neighbouring property at number 37.
