**ROAD LAYOUT
HOUSING DEVELOPMENT
FROGSTON ROAD (POD H)
EDINBURGH**

STAGE 3 ROAD SAFETY AUDIT
(SPA Ref No: 4282)

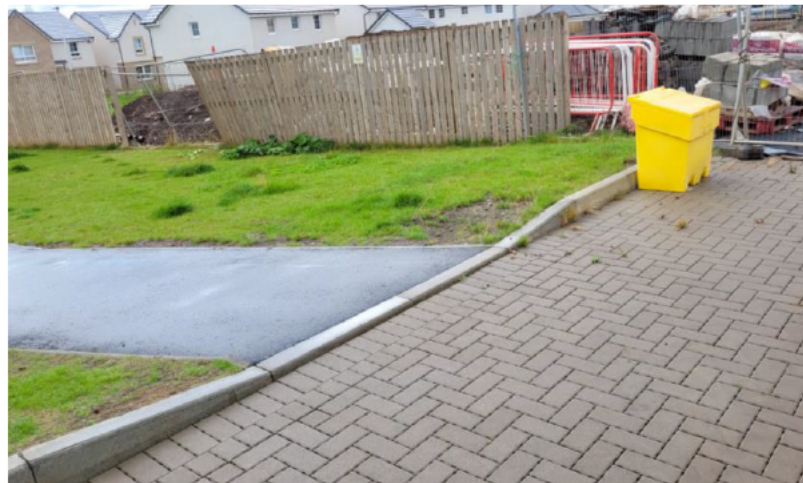
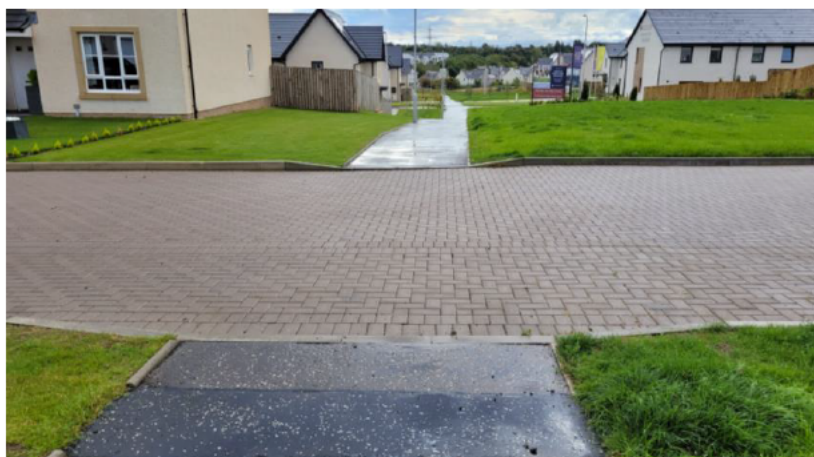
4.4.1

Location: Footpath at east end of Pod I (Arkaig Gardens and Macmath Gait)

Drawing(s): E9876~0925

Summary: Accessible dropped kerbs at a height of 0-6mm help reduce tripping type accidents and improve accessibility.

RECOMMENDATION

It is recommended that the kerb heights on this footpath be reviewed with a view to providing them at an accessible height.

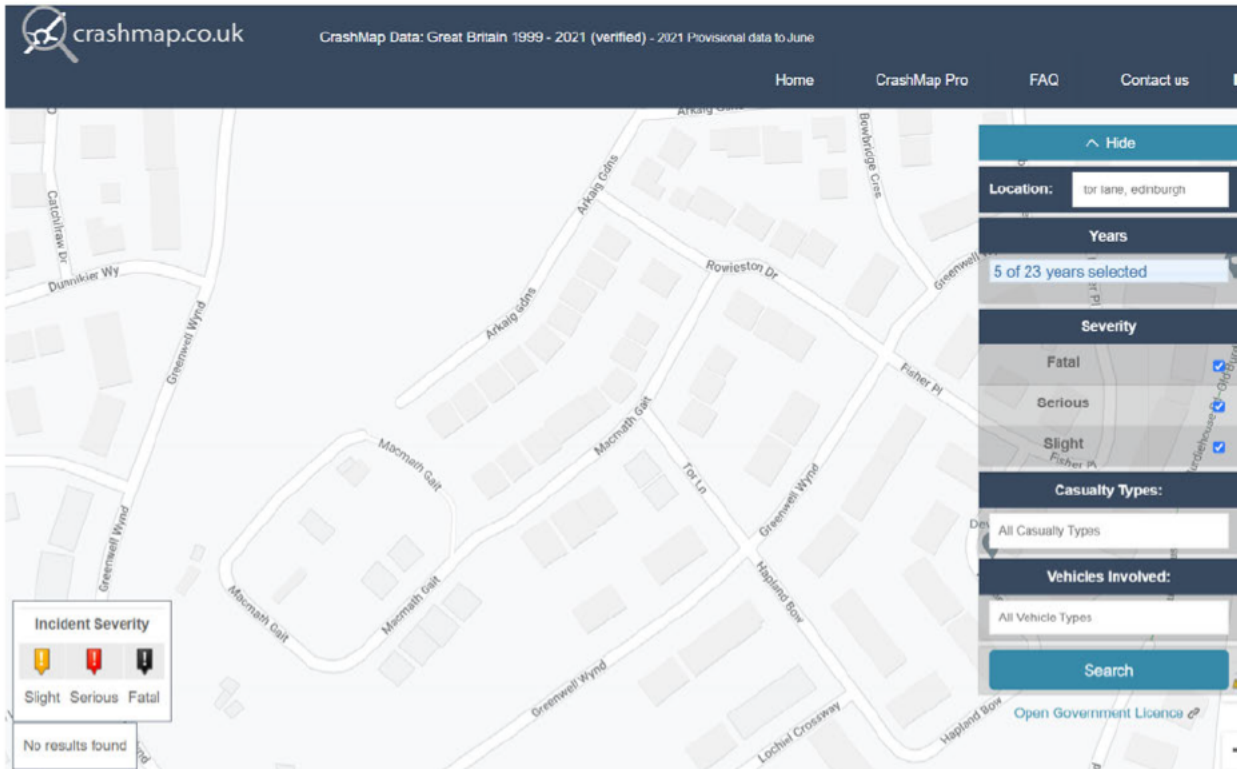
Annex 3 ACCIDENT RECORD

The screenshot displays the CrashMap.co.uk interface. At the top, the logo and navigation links (Home, CrashMap Pro, FAQ, Contact us) are visible. The main area shows a map of Frogston Road, Pod H, with various streets labeled such as Greenwell Wynd, Macmath Gait, and Fisher Pl. A search filter panel on the right includes the following options:

- Location: tor lane, edinburgh
- Years: 5 of 23 years selected
- Severity: Fatal, Serious, Slight (all checked)
- Casualty Types: All Casualty Types
- Vehicles Involved: All Vehicle Types
- Search button

In the bottom left corner, an 'Incident Severity' legend shows icons for Slight (yellow), Serious (red), and Fatal (black). Below the legend, a message states 'No results found'.
