**ROAD LAYOUT
HOUSING DEVELOPMENT
FROGSTON ROAD (POD J)
EDINBURGH**

STAGE 3 ROAD SAFETY AUDIT
(SPA Ref No: 4282)

Roads Authority: The City of Edinburgh Council

Client: Barratt Homes

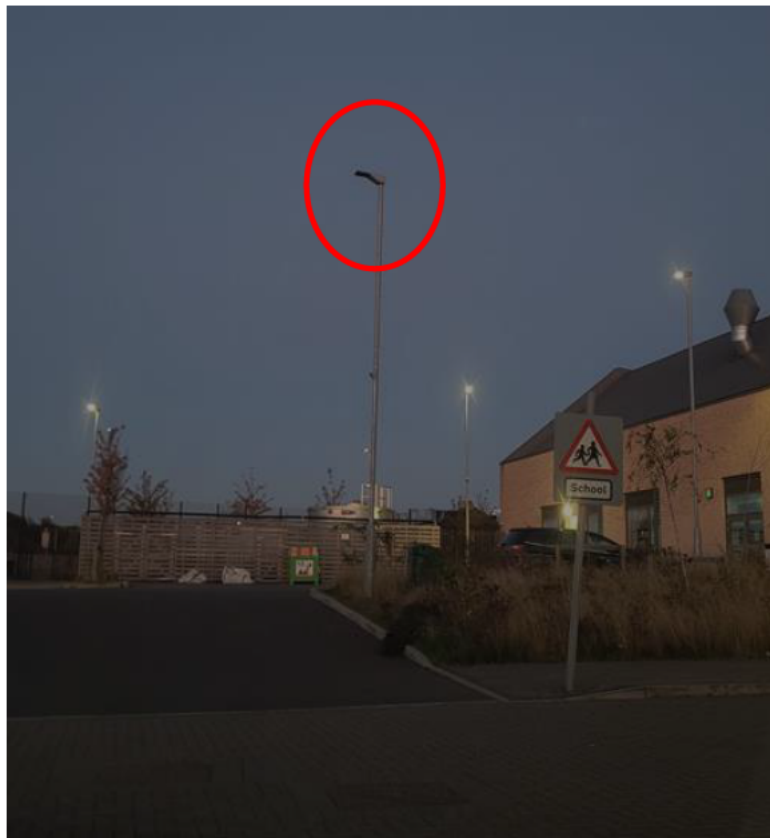
Location: Frogston Primary School, entry to car park

Summary: Non-functioning lamps on lighting columns can result in dark area on carriageway and footways that can increase the potential for vehicles striking, and pedestrians tripping on, objects or defects.

At the night-time inspection it was noted that the lighting column at the entry to the Primary School car park was 'dark'.

It is understood from the latest lighting plans that this lighting column is not part of the Barratts development and purely related to the Primary School. As such it is recommended that this lighting column be made operational by the Council as soon as possible.

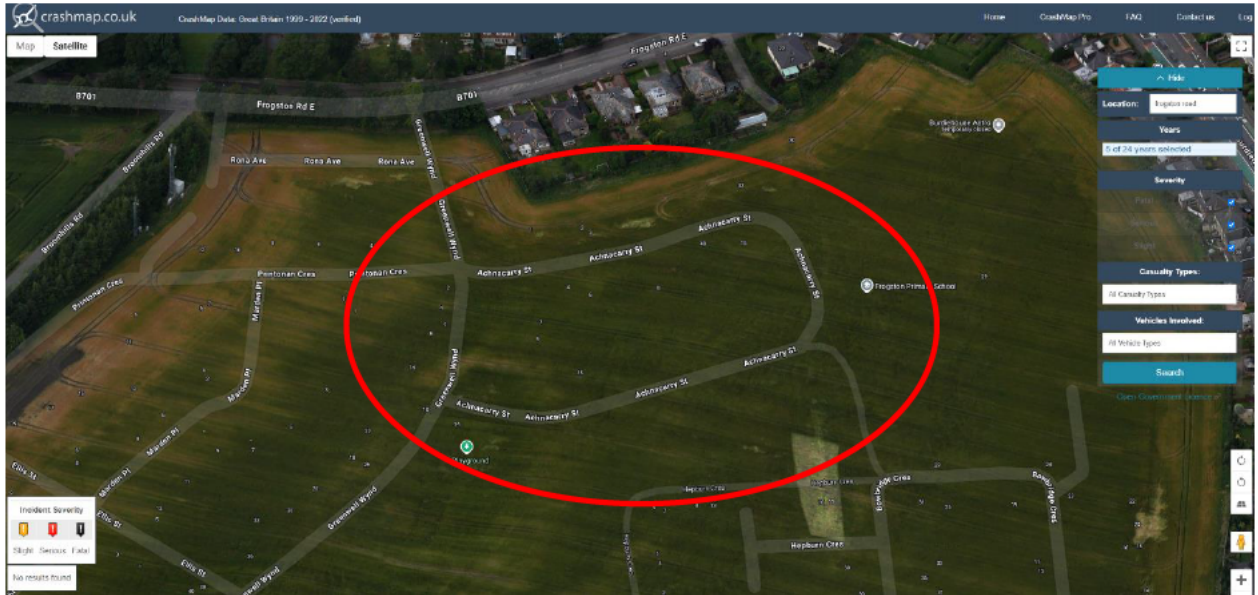
Annex 3 ACCIDENT RECORD

- 2.1 In the absence of any specific accident records being provided the Road Safety Audit Team have examined the website www.crashmap.co.uk for injury accidents recorded at the site.
- 2.2 A map based plan of the accidents have been provided in Annex 3
- 2.3 It is noted that for the five-year period from 2018 -2022 there were no accidents directly related to the area of the new development.
