**Westfield Court & Alexander Drive,
EH11 2RJ**

Structural Condition Report

Project title: Westfield Court & Alexander Drive, EH11 2RJ

Document number: E20511-WRD-XX-XX-RP-S-00001

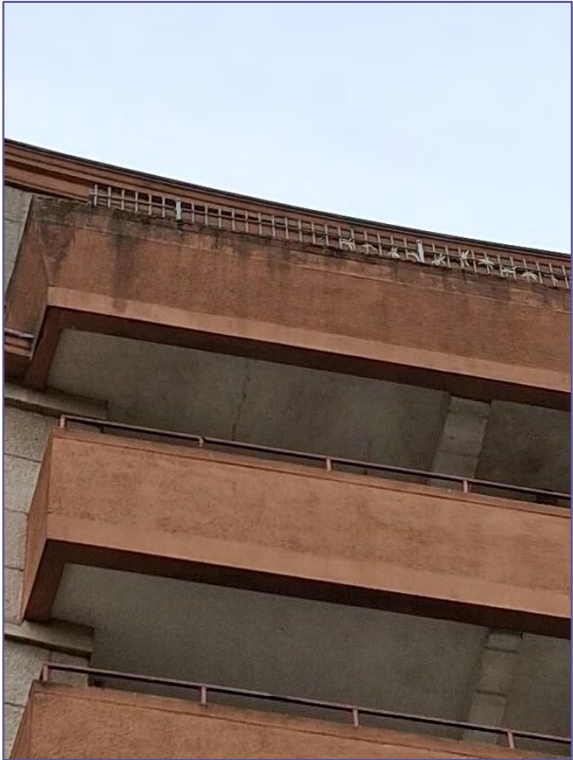
Photo 1

- No visual defects noted from ground level observations (photo 1)

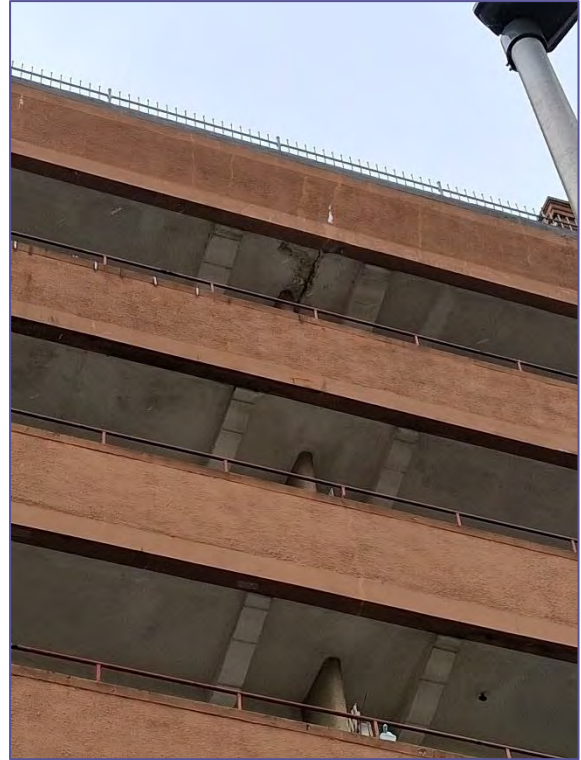
Photo 6

- Cracking and spalling can be seen on to the underside of many balcony locations which are formed of concrete slabs. (Photo 1, 6, 20, 21,22, 32).
- Large areas of vegetation growth are visible across the building elevations (Photo 24, 25).
- Evidence of patch repair to Orlit panel (Photo 31).
- Sandstone cladding feature was observed, suggesting a change in construction at this point along the elevation (Photo 27 & 28).
- Cracking and spalling are noted across the 'boot' end of the perimeter concrete beam or 'stringer' (Photo 24 & 26).

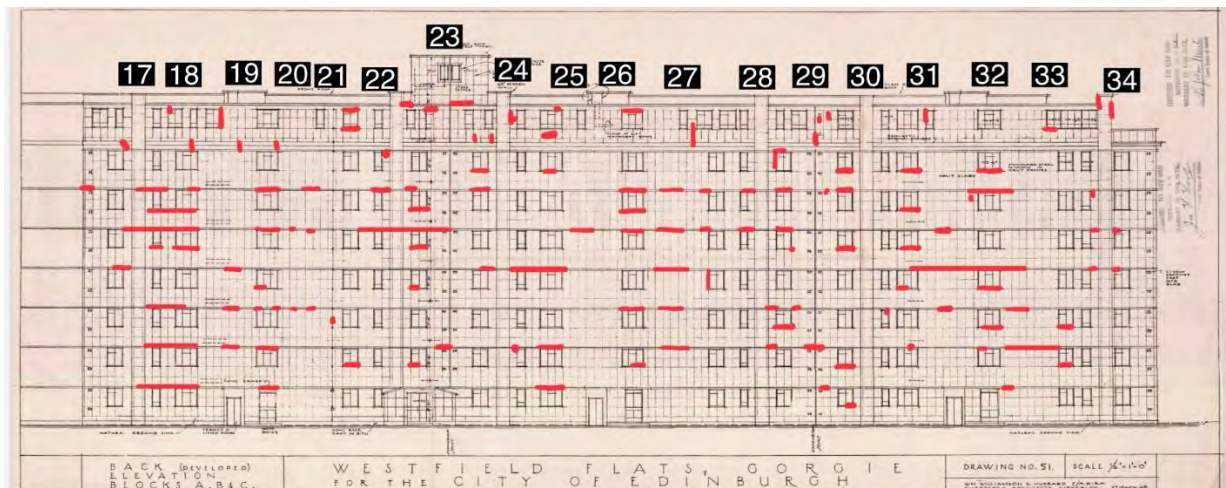
Back Elevation A, B, C

Spalling and Exposed Rebars

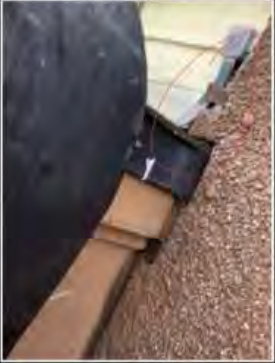
14	34 north	N/a	P2	Cladding panel damaged	Remove damaged panel, replace and point up area

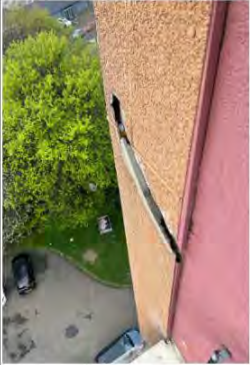
16	34 north	N/a	P2	Cladding panel damaged	Remove damaged panel, replace and point up area

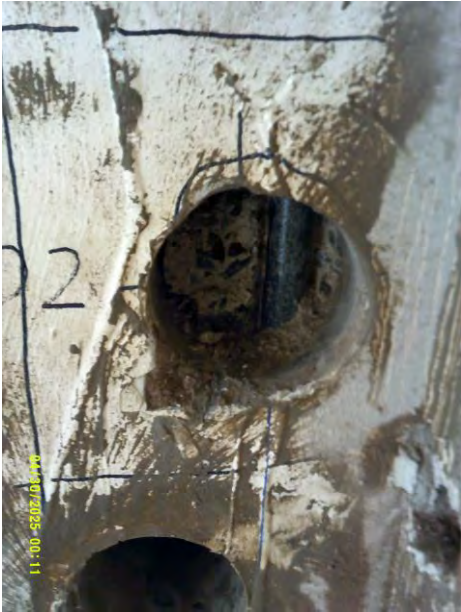
</div></div>			
<p>Breakout at location BO2 Column shows 25.4mm Round Vertical Main Bar Link Spacing 200mm 25mm Cover</p>			
<p>NOTES:- Drawings not to scale. Reference Photographs 54-55</p>			
Capital Testing Services Ltd Units 13/14 Laverock Road Stirling Road Industrial Estate Airdrie	PROJECT: Flat 2/1 Westfield Court, Edinburgh	CLIENT: Will Rudd Davidson 43 York Place, Edinburgh	PREPARED BY: <div></div>
			DATE: April 2025
			SHEET NO.: b5c4

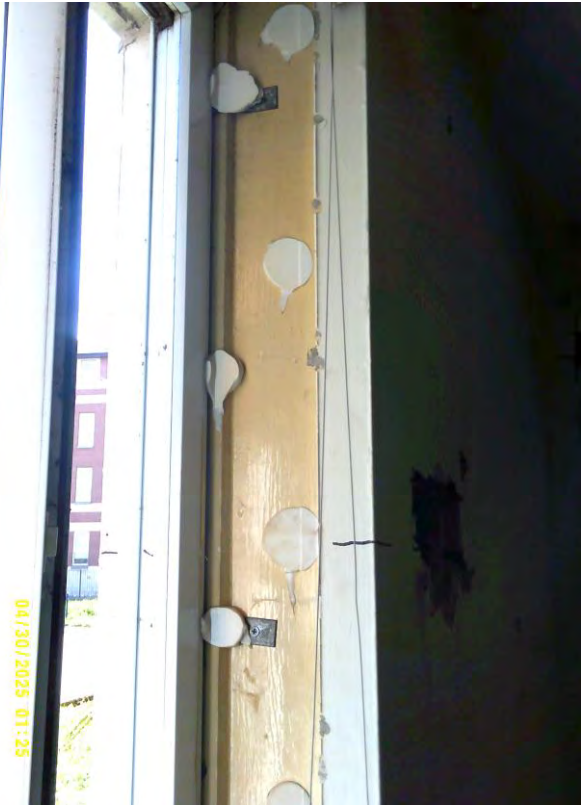
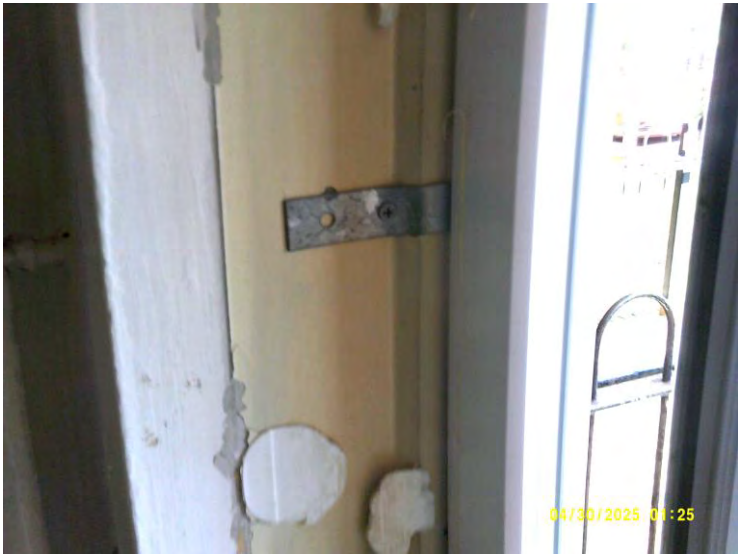
WINDOW FRAME CONNECTIONS

Typical Window Frame Connections
